# 2011 Depreciation Report

West Royal, 328 Taylor Way, West Vancouver, BC

SUBMITTED BY RDH Building Engineering Ltd.  
224 West 8th Avenue  
Vancouver BC V5Y 1N5

PROJECT # 5185.00

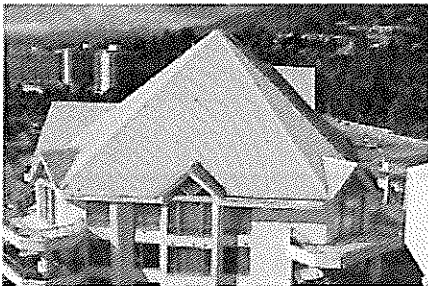
Encl 02

Metal Roof

**Description:** Standing seam roof panels over furring channels on structural steel framing. The roof panels are made from sheet steel with a painted coating. Townhouse roof turrets replaced 2009.

<b>Chronological Age:</b>	20	<b>Service Life:</b>	40
<b>Effective Age:</b>	20	<b>Remaining Service Life:</b>	20
		<b>Outstanding Conditions:</b>	0

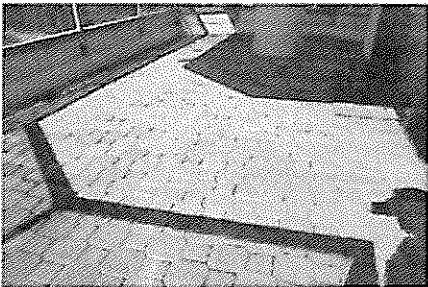
Encl 03

Decks w/ Pavers

**Description:** 2-ply SBS membrane overlaid with drainage mat, rigid insulation, filter fabric and concrete pavers. The membrane is concealed, and fully bonded to the substrate. Replacement of the existing deck membrane has been carried out at various tower units over the past 4 years. Replacement of the townhouse main roof deck was completed in 2009.

<b>Chronological Age:</b>	20	<b>Service Life:</b>	25
<b>Effective Age:</b>	20	<b>Remaining Service Life:</b>	5
		<b>Outstanding Conditions:</b>	0

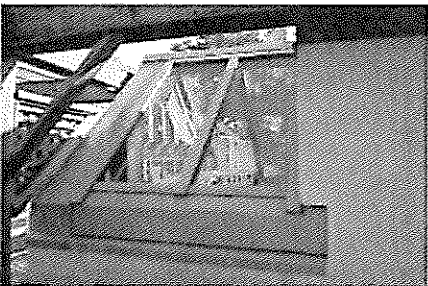
Encl 04

Sloped Glazing

<b>Chronological Age:</b>	1	<b>Service Life:</b>	40
<b>Effective Age:</b>	1	<b>Remaining Service Life:</b>	39
		<b>Outstanding Conditions:</b>	0

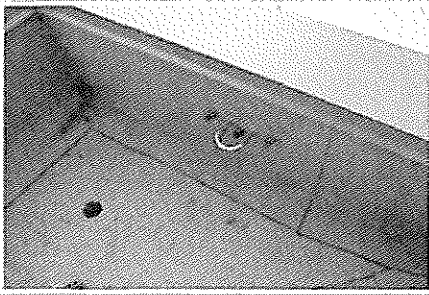
**Encl 05**

**Fall Protection Equipment**

<b>Chronological Age:</b>	20	<b>Service Life:</b>	25
<b>Effective Age:</b>	20	<b>Remaining Service Life:</b>	5
		<b>Outstanding Conditions:</b>	0

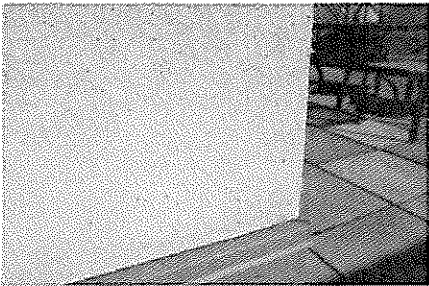
**Encl 06**

**Rainscreen Stucco Cladding**

**Description:** Acrylic coated stucco with drainage cavity, insulation on exterior gypsum sheathing with a waterproof membrane. The wall assembly replaced the existing EIFS cladding which was removed during the 2009 roof renewal.

<b>Chronological Age:</b>	3	<b>Service Life:</b>	40
<b>Effective Age:</b>	3	<b>Remaining Service Life:</b>	37
		<b>Outstanding Conditions:</b>	0

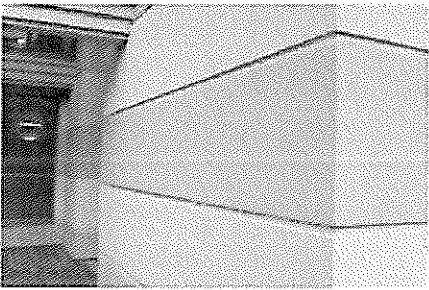
**Encl 07**

**EIFS Cladding**

<b>Chronological Age:</b>	20	<b>Service Life:</b>	25
<b>Effective Age:</b>	17	<b>Remaining Service Life:</b>	8
		<b>Outstanding Conditions:</b>	0

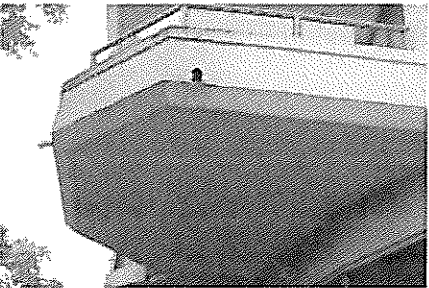
**Encl 08**

**Coated Concrete Frame**

<b>Chronological Age:</b>	20	<b>Service Life:</b>	10
<b>Effective Age:</b>	7	<b>Remaining Service Life:</b>	3
		<b>Outstanding Conditions:</b>	0

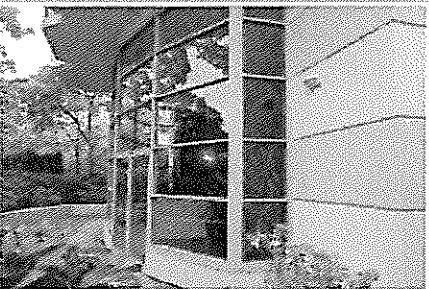
**Encl 09**

**Storefront Windows and Doors**

<b>Chronological Age:</b>	20	<b>Service Life:</b>	30
<b>Effective Age:</b>	20	<b>Remaining Service Life:</b>	10
		<b>Outstanding Conditions:</b>	0

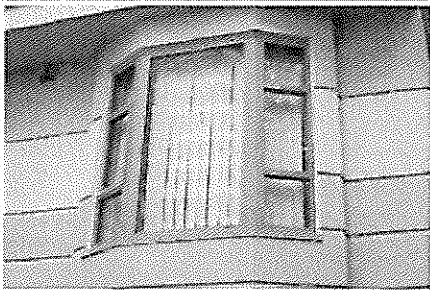
**Encl 10**

**Aluminum Windows**

**Location:** Townhouses and both towers (floors above main).  
**Description:** Aluminum framed, thermally broken, with double glazed insulated glazing units. Some windows have awning operable vents.  
**Chronological Age:** 20                      **Service Life:** 40  
**Effective Age:** 32                      **Remaining Service Life:** 8  
**Outstanding Conditions:** 0

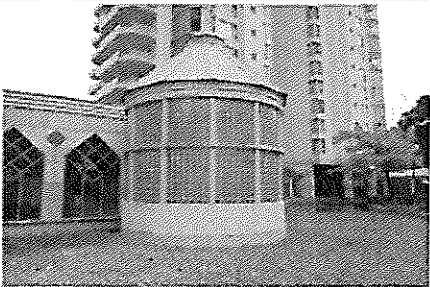
**Encl 11**

**Glass Block Windows**

**Location:** Townhouses and pool.  
**Description:** Glass block windows with concealed structural framing.  
**Chronological Age:** 20                      **Service Life:** 35  
**Effective Age:** 20                      **Remaining Service Life:** 15  
**Outstanding Conditions:** 0

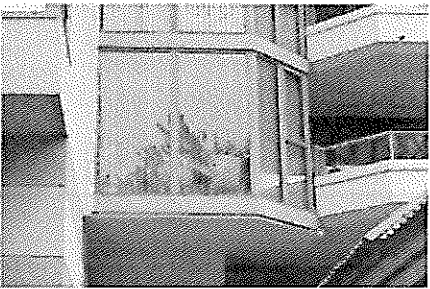
**Encl 12**

**Window Wall**

**Location:** East and west tower solariums.  
**Description:** Aluminum framed window wall with double glazed insulated units.  
**Chronological Age:** 20                      **Service Life:** 40  
**Effective Age:** 20                      **Remaining Service Life:** 20  
**Outstanding Conditions:** 0

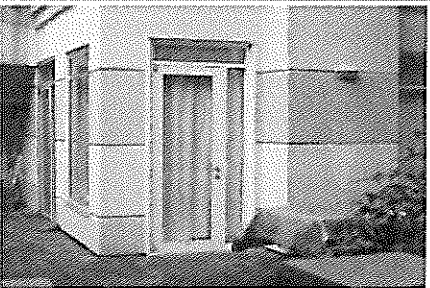
**Encl 13**

**Aluminum Swing Doors**

**Location:** Both towers and townhouses.  
**Description:** Aluminum frames out-swing doors some with transoms and side lites.  
**Chronological Age:** 2                      **Service Life:** 20  
**Effective Age:** 2                      **Remaining Service Life:** 18  
**Outstanding Conditions:** 0

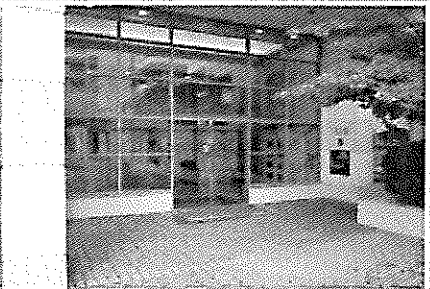
**Encl 14**

**Lobby Door Assemblies**

**Location:** Lobby entrances to both towers.  
**Description:** Commercial glazing system with closers, magnetic locks and electric strike.  
**Chronological Age:** 20                      **Service Life:** 20  
**Effective Age:** 15                      **Remaining Service Life:** 5  
**Outstanding Conditions:** 0

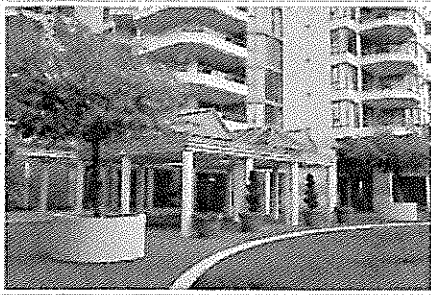
**Encl 20**

**Metal & Glass Canopies**

**Location:** Entrance to both towers and covered walkways  
**Description:** Metal framed canopy with glass panels.  
**Chronological Age:** 20                      **Service Life:** 40  
**Effective Age:** 20                      **Remaining Service Life:** 20  
**Outstanding Conditions:** 0

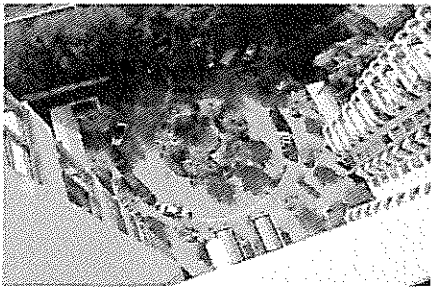
**Encl 21**

**At-grade Waterproofing**

**Location:** Parkade podium.  
**Description:** Waterproof membrane overburdened with hard landscaping or soil, plantings, water features and irrigation sprinkler piping.  
**Chronological Age:** 20                      **Service Life:** 30  
**Effective Age:** 28                      **Remaining Service Life:** 2  
**Outstanding Conditions:** 0

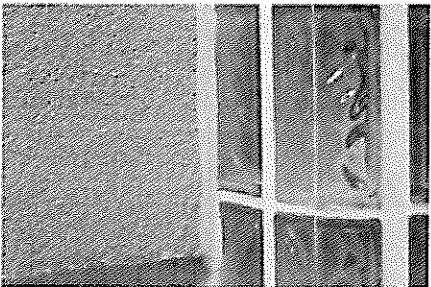
**Encl 22**

**Exterior Sealant**

**Location:** Sealant installed at interfaces between various exterior elements (i.e., window to wall interface).  
**Description:** A flexible material used to seal a gap between two surfaces to prevent leakage of water and air.  
**Chronological Age:** 5                      **Service Life:** 15  
**Effective Age:** 5                      **Remaining Service Life:** 10  
**Outstanding Conditions:** 0

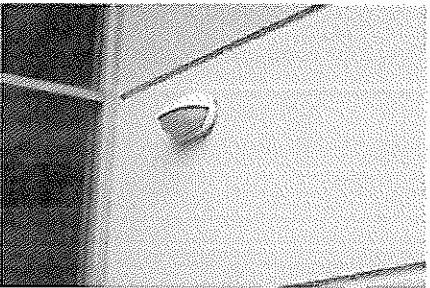
**Elec 04**

**Exterior Light Fixtures**

<b>Chronological Age:</b>	20	<b>Service Life:</b>	20
<b>Effective Age:</b>	20	<b>Remaining Service Life:</b>	0
		<b>Outstanding Conditions:</b>	0

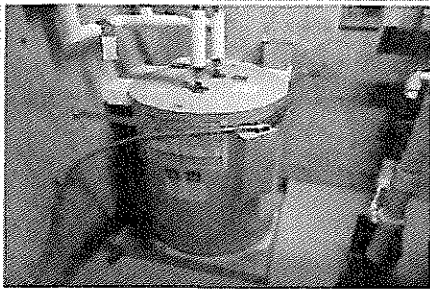
**Mech 12**

**Electric HW Reheat Tank**

<b>Chronological Age:</b>	3	<b>Service Life:</b>	5
<b>Effective Age:</b>	3	<b>Remaining Service Life:</b>	2
		<b>Outstanding Conditions:</b>	0

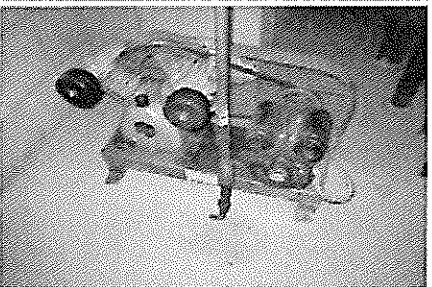
**Fire 03**

**Dry Sprinkler Compressor**

**Location:** Sprinkler room.  
**Description:** Swan compressor, model SVU 101, with 1 HP motor and 225 U/min. capacity to increase the pressure of air in the fire sprinkler lines.  
**Chronological Age:** 20                      **Service Life:** 14  
**Effective Age:** 14                      **Remaining Service Life:** 0  
**Outstanding Conditions:** 0

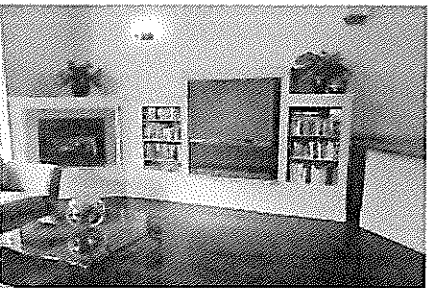
**Amen 07**

**Audio Visual Equipment**

**Location:** West tower amenity room.  
**Description:** Projector screen television and wall mounted surround sound speaker system.  
**Chronological Age:** 20                      **Service Life:** 10  
**Effective Age:** 10                      **Remaining Service Life:** 0  
**Outstanding Conditions:** 0
