# 2011 Depreciation Report

West Royal, 328 Taylor Way, West Vancouver, BC

SUBMITTED BY RDH Building Engineering Ltd.  
224 West 8th Avenue  
Vancouver BC V5Y 1N5

PROJECT # 5185.00

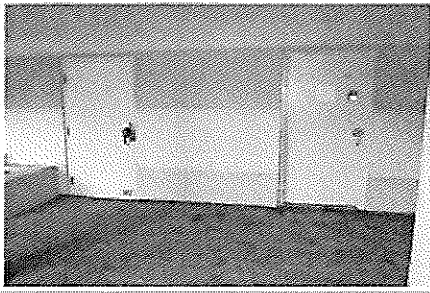
**Encl 15**

**Location:** Building exit doors & service rooms.

**Description:** Steel frame exterior doors, some with glazing, used for exit doors and service rooms.

<b>Chronological Age:</b>	20	<b>Service Life:</b>	25
<b>Effective Age:</b>	16	<b>Remaining Service Life:</b>	9
		<b>Outstanding Conditions:</b>	0

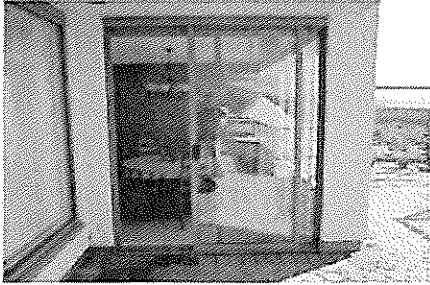
**Encl 16**

**Location:** Balconies, decks & patios.

**Description:** Aluminum framed sliding exterior doors with insulated glazing units.

<b>Chronological Age:</b>	20	<b>Service Life:</b>	20
<b>Effective Age:</b>	12	<b>Remaining Service Life:</b>	8
		<b>Outstanding Conditions:</b>	0

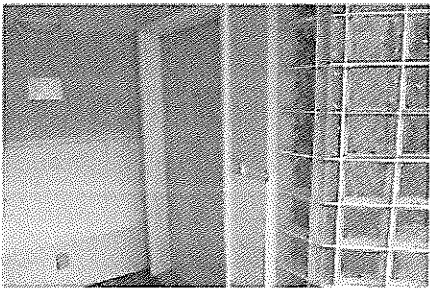
**Encl 17**

**Location:** Townhouses.

<b>Chronological Age:</b>	20	<b>Service Life:</b>	25
<b>Effective Age:</b>	20	<b>Remaining Service Life:</b>	5
		<b>Outstanding Conditions:</b>	0

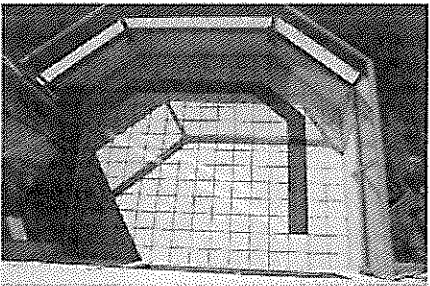
**Encl 18**

**Location:** Balconies.

**Description:** Concrete slabs overlaid with ceramic tiles on thin set mortar bed.

<b>Chronological Age:</b>	20	<b>Service Life:</b>	30
<b>Effective Age:</b>	20	<b>Remaining Service Life:</b>	10
		<b>Outstanding Conditions:</b>	0

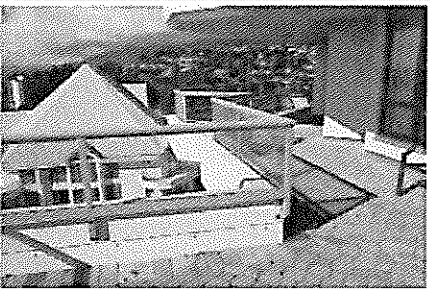
**Encl 19**

**Location:** Decks & balconies

<b>Chronological Age:</b>	20	<b>Service Life:</b>	40
<b>Effective Age:</b>	20	<b>Remaining Service Life:</b>	20
		<b>Outstanding Conditions:</b>	0

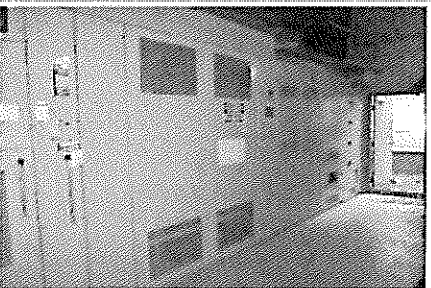
**Elec 01**

**Distribution Transformers**

**Location:** Main electrical rooms (east & west towers) & roof top mechanical rooms.  
**Description:** Skyway 1750 KVA ventilated, 3 phase, dry-type, with NEMA enclosure, coil and vibration isolators that provide power to receptacles and low voltage loads. System also includes Federal Pioneer & Hammond 450, 75(2) & 30(2) KVA sub-transformers.  
**Chronological Age:** 20                      **Service Life:** 40  
**Effective Age:** 20                      **Remaining Service Life:** 20  
**Outstanding Conditions:** 0

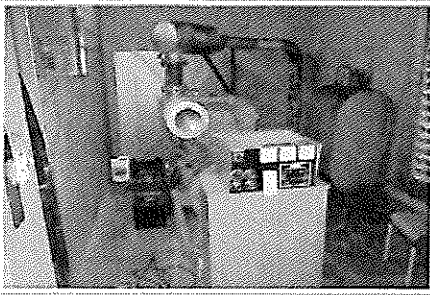
**Elec 02**

**Emergency Generator**

<b>Chronological Age:</b>	20	<b>Service Life:</b>	35
<b>Effective Age:</b>	20	<b>Remaining Service Life:</b>	15
		<b>Outstanding Conditions:</b>	0

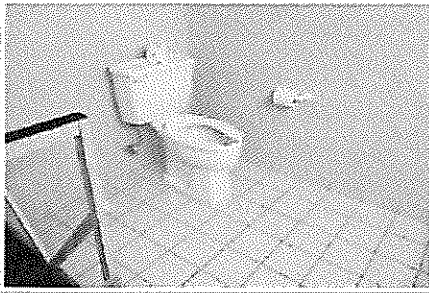
**Mech 06**

**Location:** Amenity room m/f washrooms, pool change rooms & corporate suite.

**Effective Age:** 20                      **Remaining Service Life:** 10

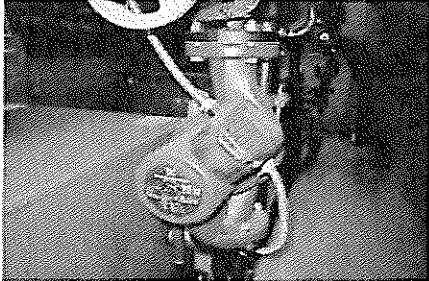
**Mech 07**

**Location:** P1 boiler room, valve room, sprinkler room & rooftop mechanical rooms.

**Effective Age:** 3                      **Remaining Service Life:** 5

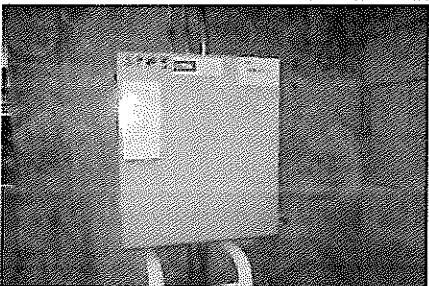
**Mech 08**

**Location:** P1 stall 337 (simplex), Storage 1 (simplex), P2 stall 3 (duplex), P2 stall 126 (duplex)

**Effective Age:** 14                      **Remaining Service Life:** 1

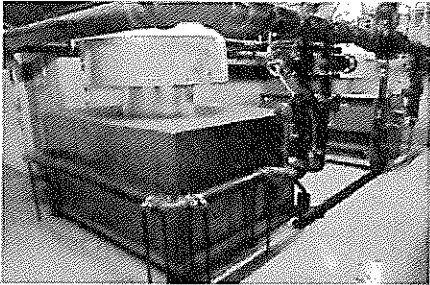
**Mech 13**

**DHW Boilers - Gas Fired**

**Description:** Allied Engineering, model AAE-2400-N-E, gas fired water heaters, which supply hot water during medium and high demand periods. Boilers are connected to electric storage tanks.

<b>Chronological Age:</b>	3	<b>Service Life:</b>	20
<b>Effective Age:</b>	3	<b>Remaining Service Life:</b>	17
		<b>Outstanding Conditions:</b>	0

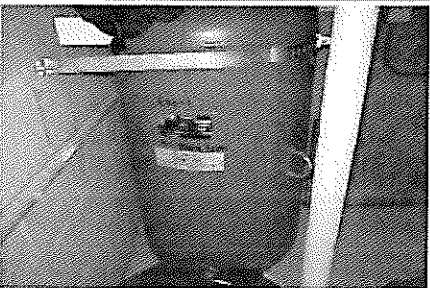
**Mech 14**

**Expansion Tanks**

<b>Chronological Age:</b>	3	<b>Service Life:</b>	20
<b>Effective Age:</b>	3	<b>Remaining Service Life:</b>	17
		<b>Outstanding Conditions:</b>	0

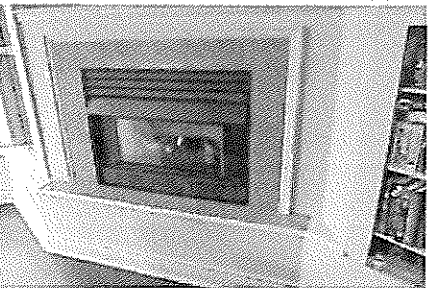
**Mech 15**

**Gas Fireplace**

**Description:** Natural gas fireplaces with fireplace enclosure, flue, gas piping, gas valve, glass panel and other components.

<b>Chronological Age:</b>	2	<b>Service Life:</b>	30
<b>Effective Age:</b>	2	<b>Remaining Service Life:</b>	28
		<b>Outstanding Conditions:</b>	0
