## **UNDERGROUND OIL TANK (UST) GPR SCAN REPORT**

**PROPERTY ADDRESS:** 502 WEST 23rd STREET VANCOUVER

**DATE:** October 5th, 2021 @ 12:30 PM

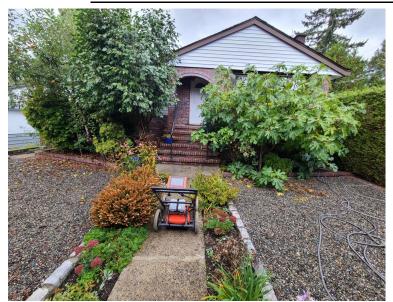
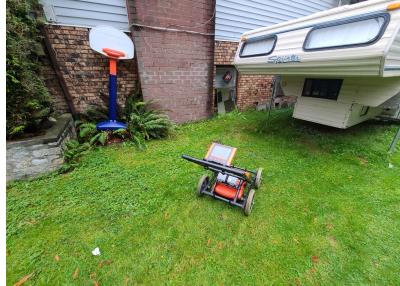
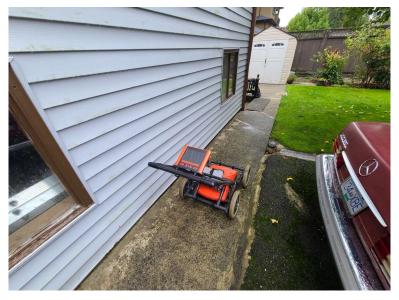
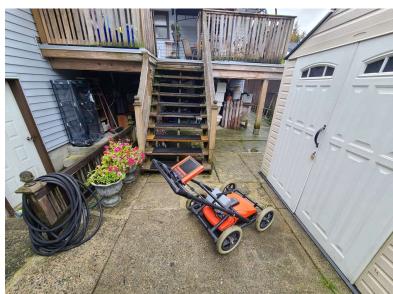
Several areas could not be scanned due to interfering objects impeding access including the following: underneath the rear deck/slab, underneath the camper on the east side, underneath the car in the parked driveway, underneath the garden shed. Underneath the rear patio was full of impeding objects. All areas mentioned are inconclusive (see below photos)

All areas of the property were scanned to the best of our ability. The front of the property was clear and scanned (no suspected tank located in this area). However, overlapping passes with the above noted equipment could not scan a majority of the property due to impeding factors (see below). SECONDARY SCAN REOURED FOR CONCLUSIVE RESULT ONCE THE PROPERTY IS CLEAR OF IMPEDING OBJECTS.
